**Flood Control Project Maintenance
Levee Inspections**
LMA District Cover Sheet
Spring 2012 Levee Inspection Results

Reclamation District No. 0108 River Farms

Spring 2012 Levee Inspection Results

Waterway			Bank	Unit Miles
Unit No. 01 Colusa Basin Drain			Left	20.59
	Spring (March - May)	Summer (June - August)	(September - November) Fall	Winter (December - February)
Unit Maintenance Rating (Fall Only)				
Date of Inspection	4/26/2012 - 4/26/2012			
DWR Inspector	John Williamson			
Accompanied By	Chad Navarrot RD 108

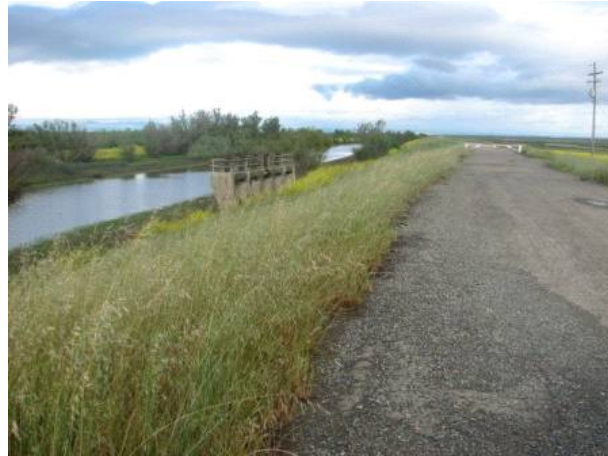
Levee Mile Report Line	4
Start Levee Mile	0.05
End Levee Mile	20.57
Location	Water Side
Category	Earthen Levee
Item	Vegetation
The grasses are taller than 12". Photo taken spring 2012.	
johngw_s_20120430_736.jpg

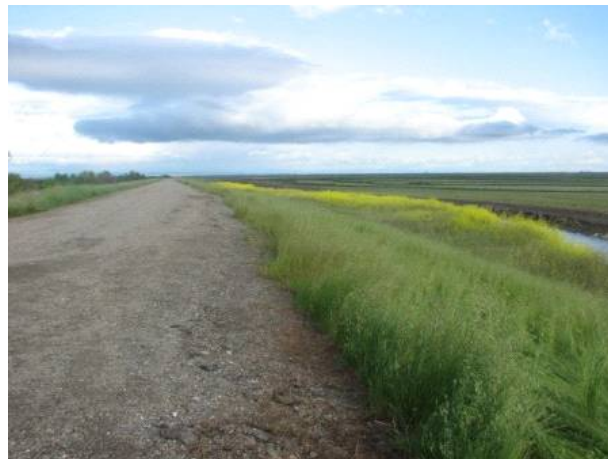
Levee Mile Report Line	5
Start Levee Mile	0.10
End Levee Mile	20.57
Location	Land Side
Category	Earthen Levee
Item	Vegetation
The grasses are taller than 12". Photo taken spring 2012.	
johngw_s_20120430_737.jpg

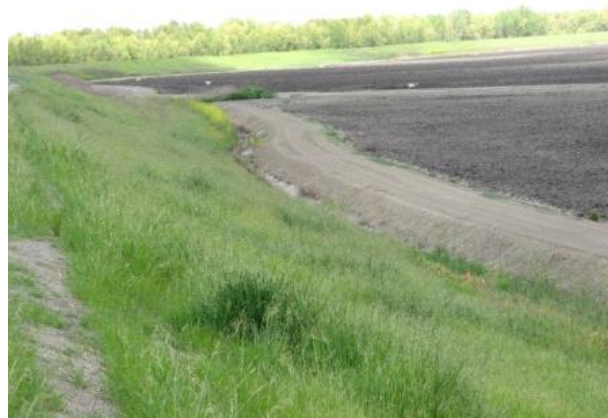
LMR No.	Levee Mile		Category	Item	Location *	Rating +	Action/Comment	GPS Latitude/Longitude		Issue No.
	Start	End						Start	End	Photo
14	18.88	19.60	Earthen Levee	Encroachments	LS	M En	AD : Agricultural Ditch	39.013245 ° -121.980795 °	39.021302 ° -121.988557 °	6 Y
								DWR ID: DWR_RD0108_01_s_2012_6		
15	19.16	19.16	Supplemental	USACE Erosion Survey	WS	M Ma	Inspector Comments: 2011: Toe scour at the bottom of a steep bank, large sections of the toe are sliding down. Erosion may be due to the upstream bend. [2011 Site ID: CBD_19-2_L]	39.016727 ° -121.985411 °	39.017516 ° -121.986374 °	3 Y
								DWR ID: DWR_RD0108_01_s_2012_3		
16	19.27	19.27	Earthen Levee	Vegetation	WS	C Ma	V2 : Remove the wild growth other than native grasses from the levee slopes. Inspector Comments: Arundo	39.017443 ° -121.985710 °	39.017443 ° -121.985710 °	9
								DWR ID: DWR_RD0108_01_s_2012_9

Levee Mile Report Line	14
Start Levee Mile	18.88
End Levee Mile	19.60
Location	Land Side
Category	Earthen Levee
Item	Encroachments
Ag. ditch	
johngw_s_20120313_282.jpg

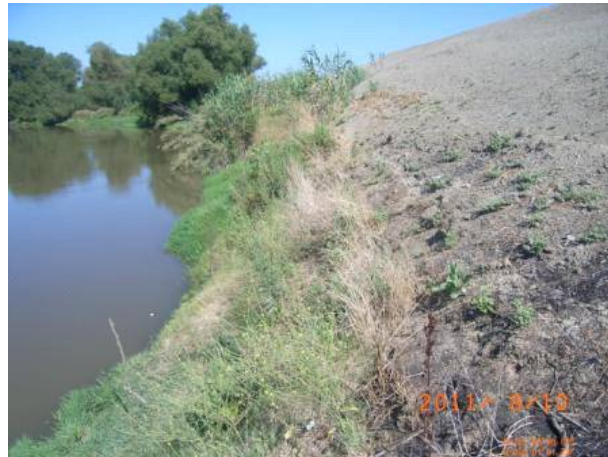
johngw_s_20120313_280.jpg

Levee Mile Report Line	15
Start Levee Mile	19.16
End Levee Mile	19.16
Location	Water Side
Category	Supplemental
Item	USACE Erosion Survey

USACE 2011 Photo #1

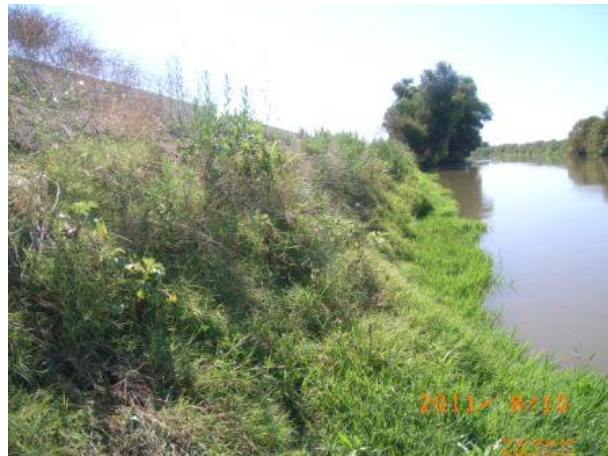
johngw_s_20120313_281.jpg

Levee Mile Report Line	15
Start Levee Mile	19.16
End Levee Mile	19.16
Location	Water Side
Category	Supplemental
Item	USACE Erosion Survey

USACE 2011 Photo #2
